IN-SITU LINE BORING

40 TONNE BULK COAL HANDLING CRANE

PROJECT FACTS: Coal Handling Crane

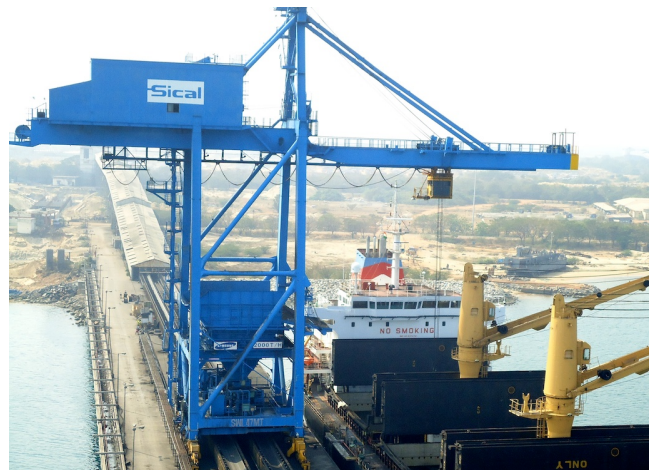
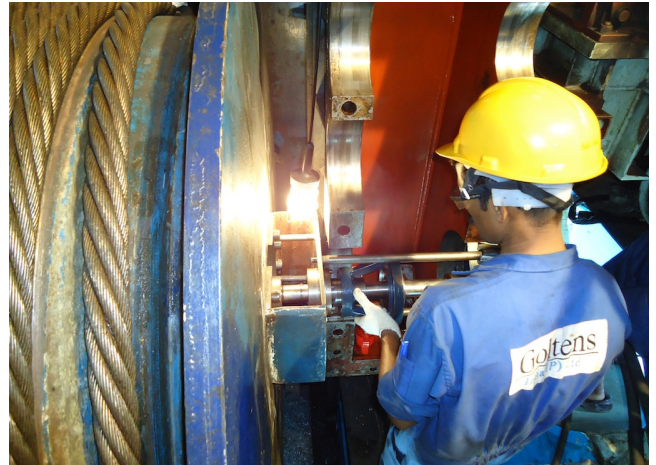
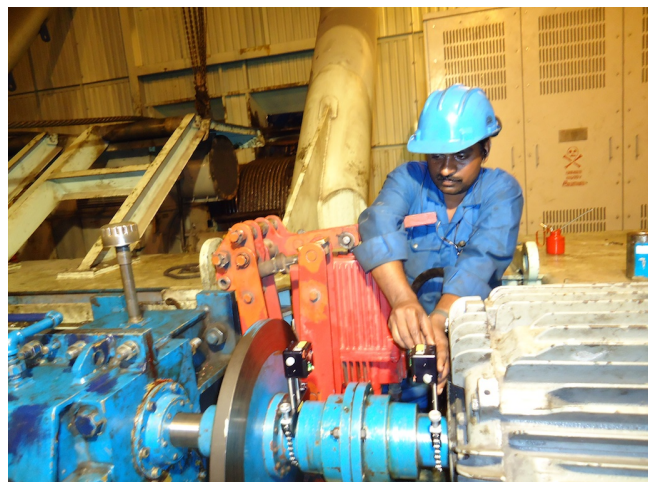
During the inspection of the cranes, Goltens Technicians discovered that the main cable drum, which is driven by a motor through a main gear box, had suffered damage to the drive shaft and the drive shaft flange bolts holes were found oval and the mating faces found worn out unevenly.

To correct the damage, Goltens proposed an in-situ line boring solution and post machining alignment. Goltens designed the fixtures and carried out the work around the clock to complete the in-situ work. The team then reassembled and aligned the complete drive system.

- Lifting of gearbox main casing and removal of the drive shaft to allow access to cable drum damaged area.
- Drum side drive shaft flange steel pad gouged out, bore area built up by welding.
- Setting up the line boring tool with required center line reference in horizontal and vertical plane with respect to Drum end plate and centerline of gear box drive shaft. Carrying out the boring to required 290mm bore.
- Welding of Pad on the drum face and Drilling of 08 nos new bolt holes for flange fitment.
- Gear Box assembled, drive shafts from both sides fitted in place, complete alignment was done as per the system drawing.
- The crane was commissioned and tested by the customer with all satisfactory results.
